Standup 2.0 Service & Maintenance Webinar

July 2023

Standup 2.0 Service & Maintenance Webinar Agenda

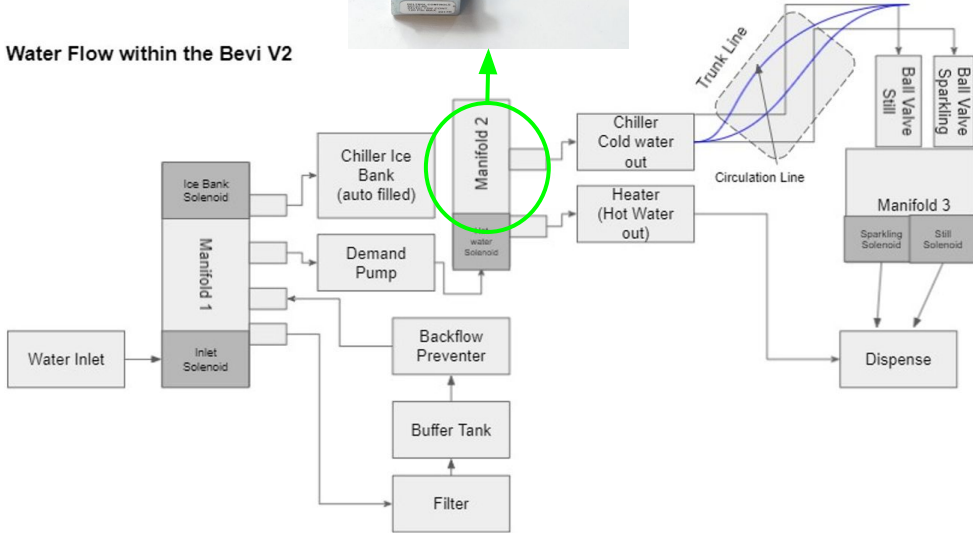
Manifold 2
(Part number:
720-0061)

Water Flow within the Bevi V2

Manifold 2 is responsible for taking the water from the demand pump and sending it to both the hot water heater and also the cold water to the chiller.

When leaks occur, they may occur from the body of the manifold (resulting in a “Water in Base” alert) or a small leak from the nozzle. The first step is to identify the source of the leak. If Manifold 2 is identified as the source, it should be replaced, using the [Swap Guide](#). A solution to the root cause of this issue is in progress.

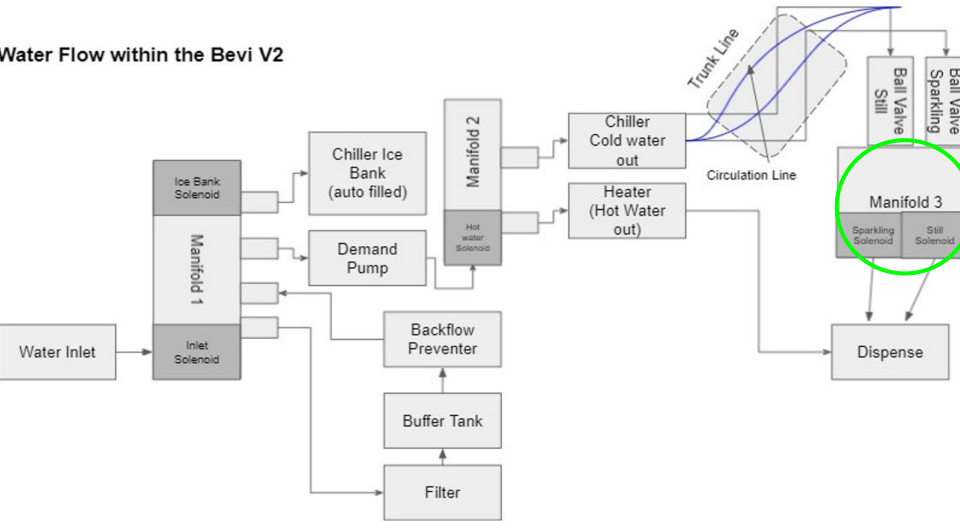
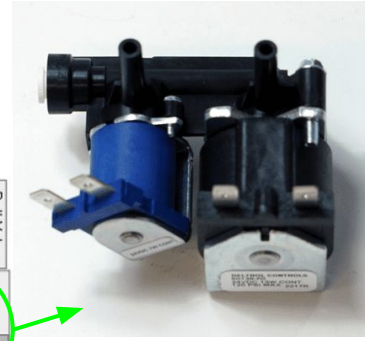
Manifold 3
(Part Number:
720-0064)

Water Flow within the Bevi V2

Manifold 3 takes chilled, ambient and sparkling water from the carbonator outputs and sends it to the nozzle assembly.

When leaks occur, they may occur from the body of the manifold (resulting in a “Water in Base” alert) or a small leak from the nozzle. The first step is to identify the source of the leak. If Manifold 3 is identified as the source, it should be replaced, using the [Swap Guide](#). A solution to the root cause of this issue is in progress.

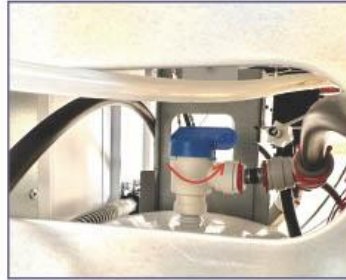
6. Turn **on** the machine, **open** the buffer tank, and turn **on** the source water supply.
Inspect for leaks.

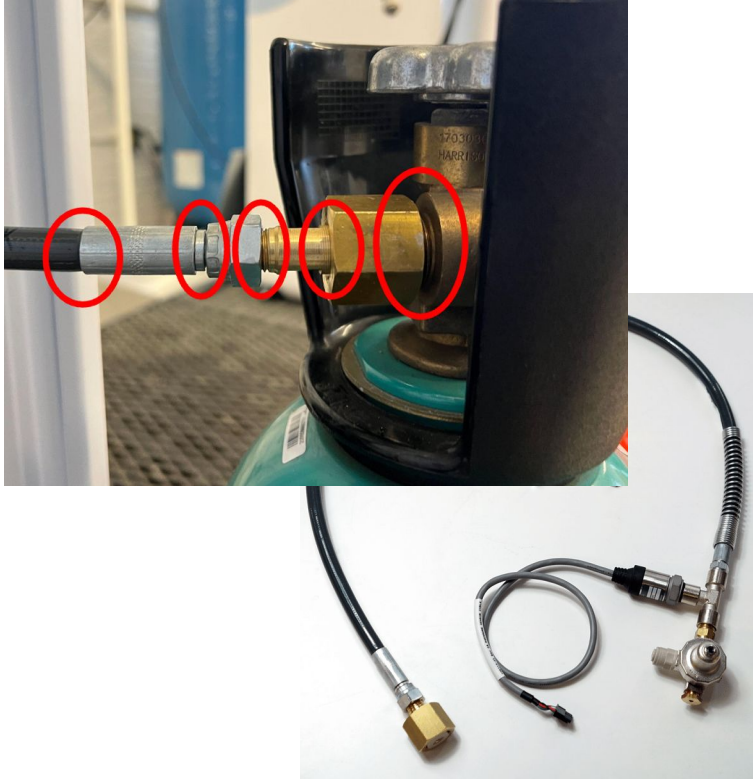
CO2 Regulator
(Part Number:
720-0062)

The CO2 assembly regulates pressure from the CO2 tank into the Standup 2.0.

In some cases, the CO2 regulator may fail or begin to leak, causing the CO2 to deplete faster than expected. When this happens, the CO2 regulator assembly may need to be replaced, using the [Swap Guide](#). Please reach out to Bevi Support to report the issue and obtain a replacement part.
