TECHNICAL BULLETIN - WATERBLOCK FITTING REPLACEMENT

Title	WATERBLOCK FITTING REPLACEMENT
Date	2020-09-24
Author	OLIVIA SCHNEIDER
For Questions Contact	SUPPORT@BEVI.CO 1-866-704-2384
Description	
<p>Bevi is transitioning from the use of a plastic fitting to a metal fitting on the waterblock. This will decrease the likelihood of a leak in the field.</p> <div style="display: flex; justify-content: space-around; align-items: center;"> <div style="text-align: center;">

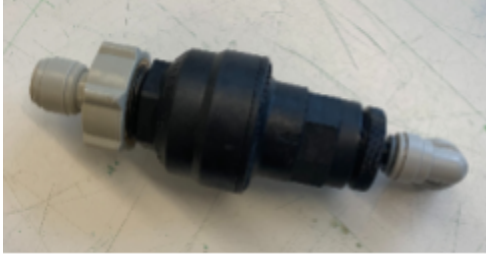
<p>Old Waterblock with Plastic Fitting</p> </div> <div style="text-align: center;">

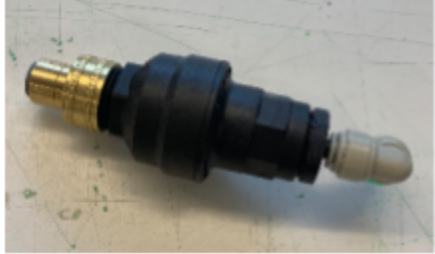
<p>New Waterblock with Metal Fitting</p> </div> </div>	
FAQs	
<ul style="list-style-type: none"> - Why does the plastic fitting need to be replaced? <ul style="list-style-type: none"> - The plastic fittings currently installed on the waterblock have shown to be the cause of leaks in the field. - How long after installation does the fitting typically fail? <ul style="list-style-type: none"> - There is no indication which fittings fail and when. - Is there a chance that the metal fittings will have the same issue? <ul style="list-style-type: none"> - Bevi tested the metal fittings and was not able to invoke any failures when installed in accordance with the procedure below. - Which Standup units need this fitting replacement? <ul style="list-style-type: none"> - Only the V1.0 and V.75 Units need to have the fitting replaced on the waterblock. V1.5 units do not have waterblocks.

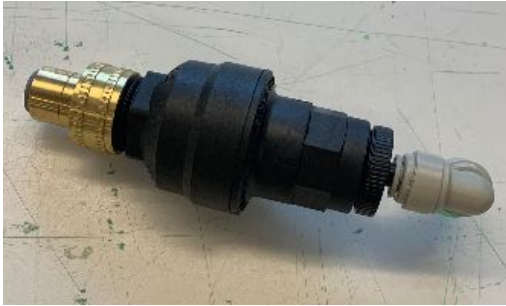
- Water Block - Metal Fitting - Elbow In: 107645-01
(if performing full water block assembly replacement)

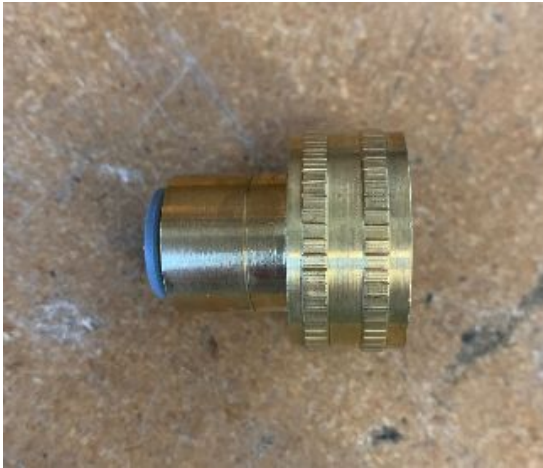
- Brass Garden Hose Adapter, $\frac{3}{8}$ " Tube x $\frac{3}{4}$ " FGH: 350-0113
(if performing only fitting replacement)

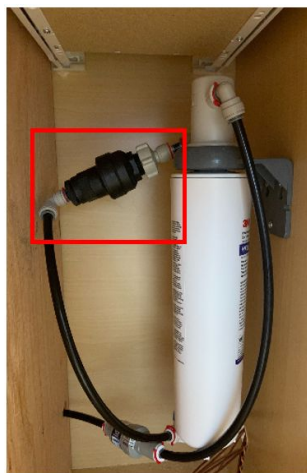
- Turn off water to the system.
- Dispense water from the head unit to relieve pressure
- Locate the water block near the filter in the cabinet.

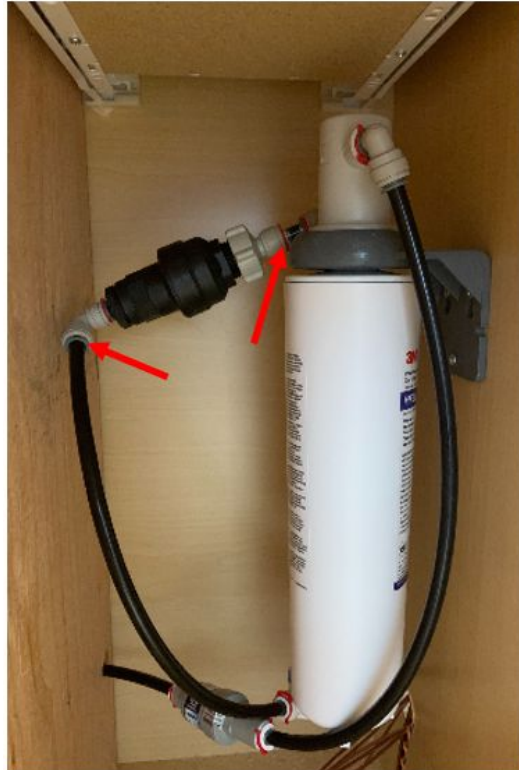
- Remove the (2) red locking clips on either side of the waterblock and detach the tubing from the fittings.

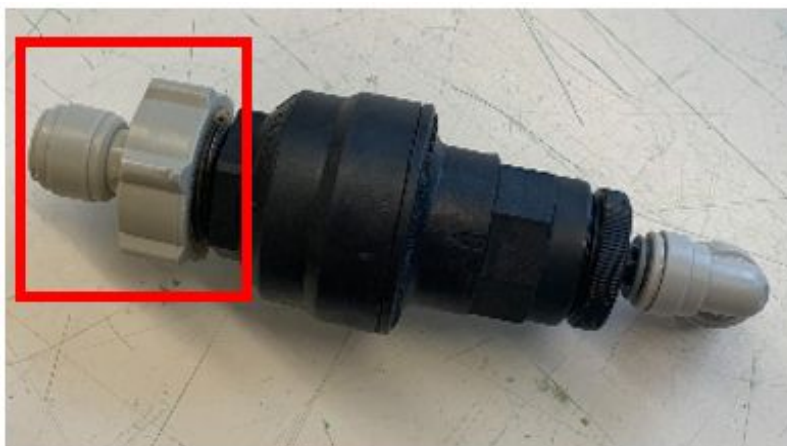
- Remove the waterblock from the system and remove the plastic fitting.

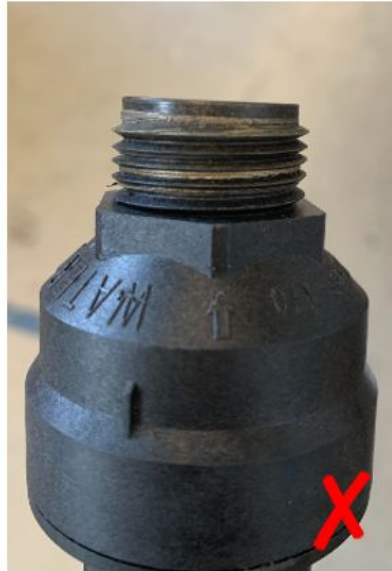
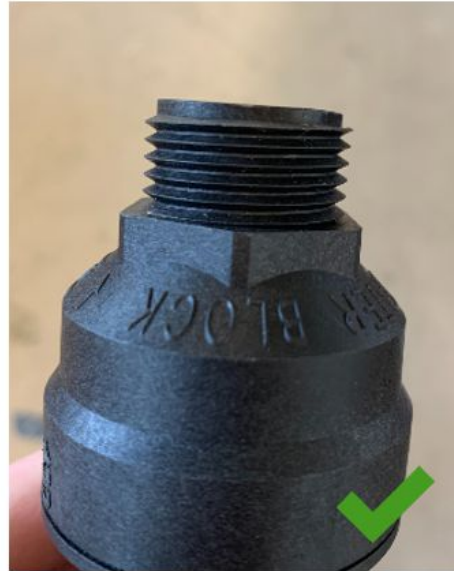
- Check the threads on the waterblock. If any are broken, replace the entire waterblock.

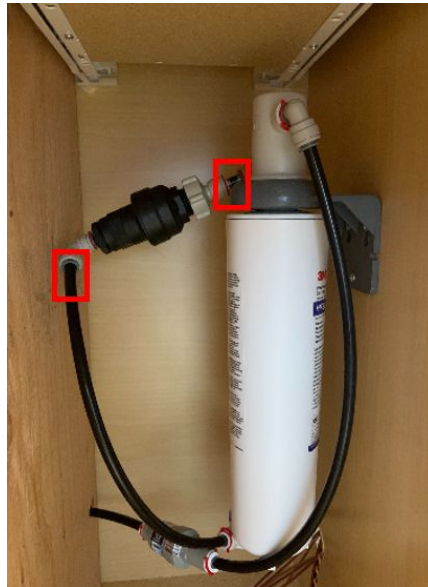
- Inspect the tubing on either side of the waterblock fittings. If worn, either replace or cut the current tube to a fresh portion of the tube.

NOTE: Do not cut tube at an angle

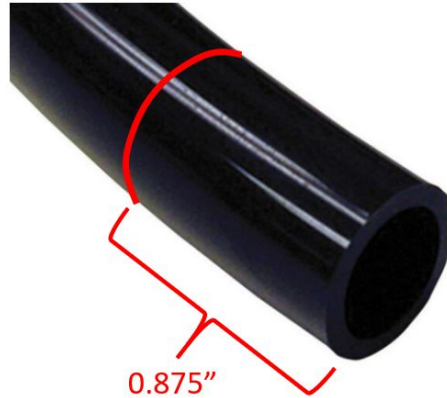
- After the tubing has been inspected, mark the tube used for the fitting $\frac{7}{8}$ " (.875") from the cut end. This step will ensure full insertion of the tubing into the fitting when the water block is reinstalled.

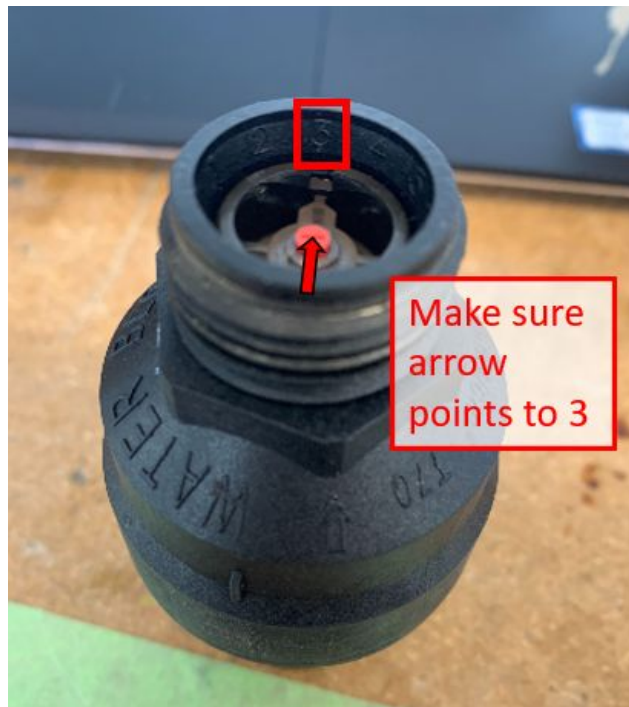
- Set the gallon setting on the waterblock to 3.
NOTE: The 3 and 8 look very similar in the small script on the waterblock, so double check that the arrow is pointing towards the 3.

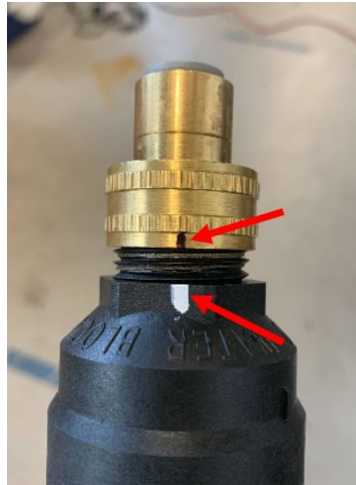
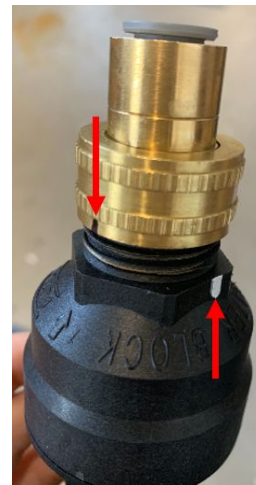
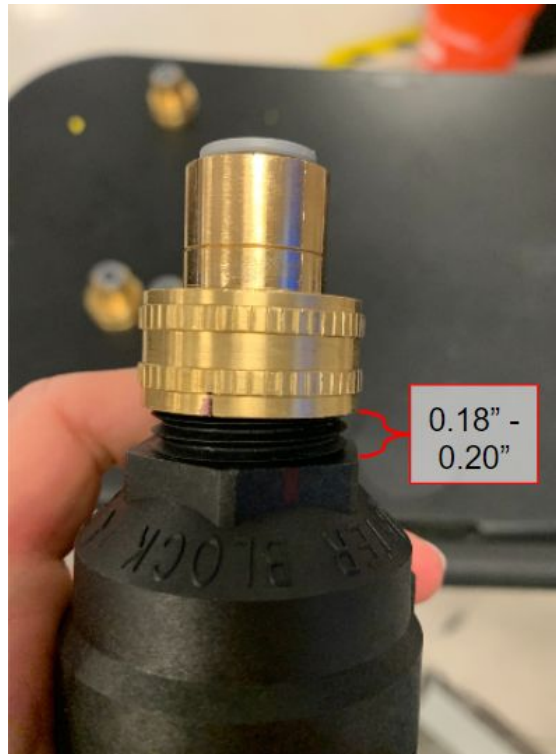
- Tighten metal fitting until hand tight and mark the waterblock and fitting to indicate this position. Then tighten $\frac{1}{4}$ to $\frac{1}{2}$ turn past the first resistance. The measured gap between fitting and waterblock should be between 0.18" and 0.20".

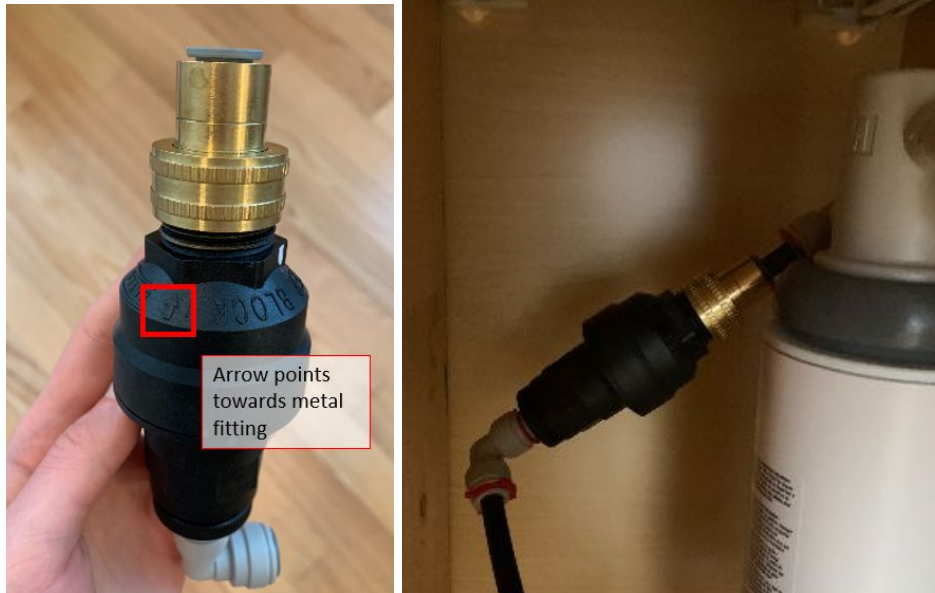
- Reinstall the waterblock with the new fitting in the cabinet and reconnect the (2) red locking clips.
- The arrow on the waterblock points in the direction of waterflow, which should be into the filter.

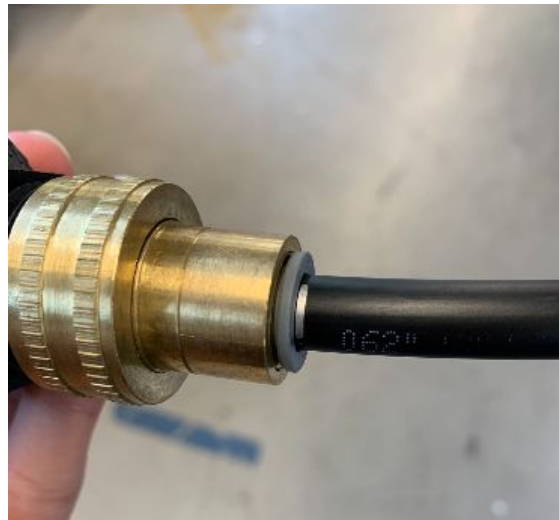
NOTE: After reinserting the waterblock, the tube markings created earlier should be visible at the edge of the fitting

- Turn on the water and observe the waterblock. Check for drips over the course of 5 minutes. If any drips are present, tighten the fitting an additional $\frac{1}{4}$ turn. If drips are still present, call tech support.

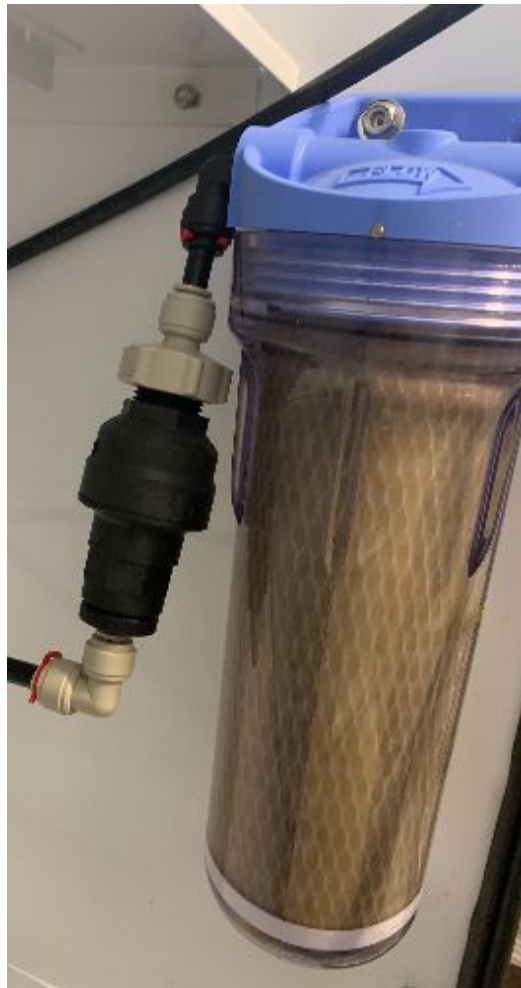
- Turn off water to the system.
- Dispense water from the Bevi to relieve pressure
- Locate the water block near the filter in the unit.

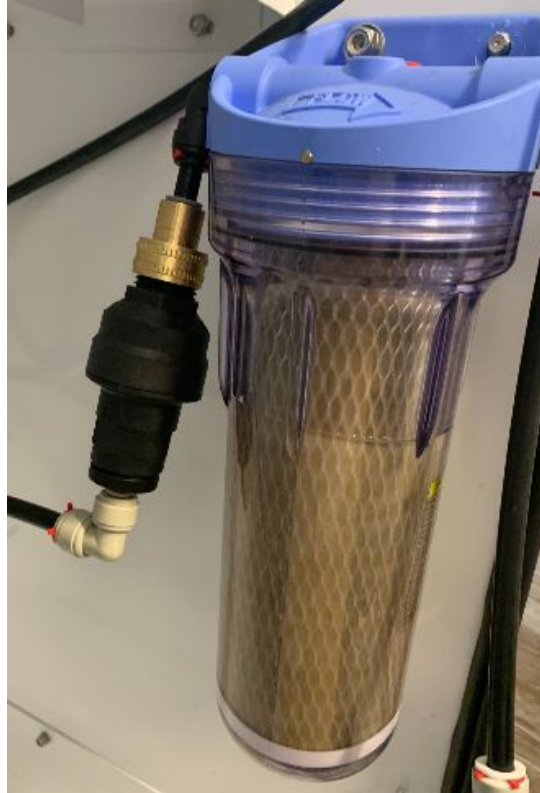
- Final installation of the waterblock in the standup unit with the metal fitting
