[Guide] Bib Line Replacement (Countertop)

This document is intended for Bevi technicians and other qualified personnel to provide step by step instructions on how to change the flavor bib lines in the Countertop (CT) Bevi machine.

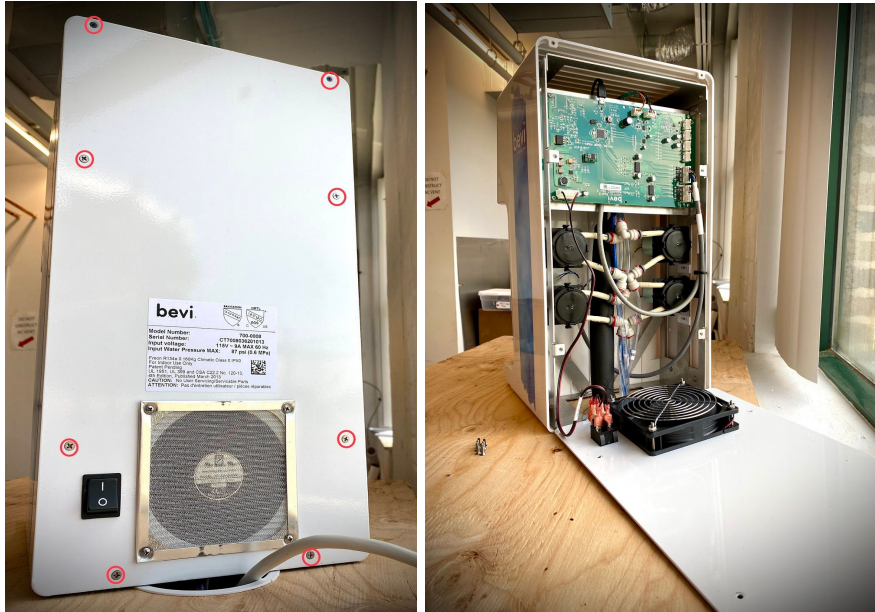
3. Disconnect the flavor line from push connector.
